Seismic Vulnerability of Primary Response Agencies in the Himalayan Province of Uttarakhand in India

Piyooosh Rautela^{1*}, Girish Chandra Joshi¹, Shailesh Ghildiyal¹

¹ Uttarakhand State Disaster Management Authority, Uttarakhand Secretariat, Dehradun – 248 001, Uttarakhand, India

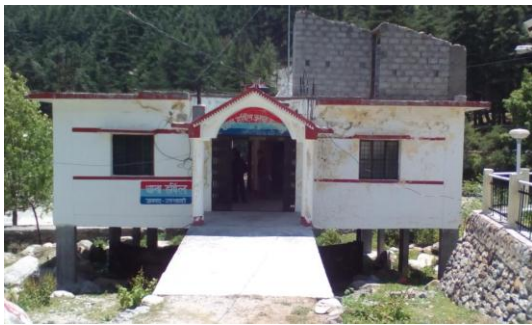
Figure 4. Single-story Police Station building at Harsil in Uttarkashi district built on stilts

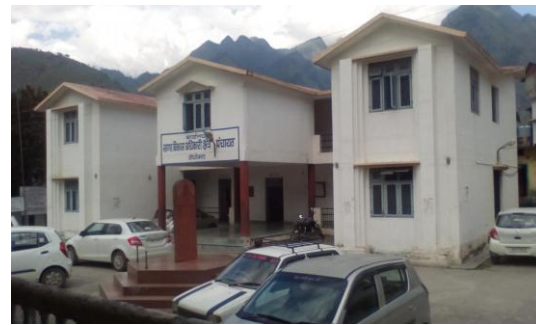
Figure 5. Double-story RCC Block Development Office building at Joshimath (Chamoli district)

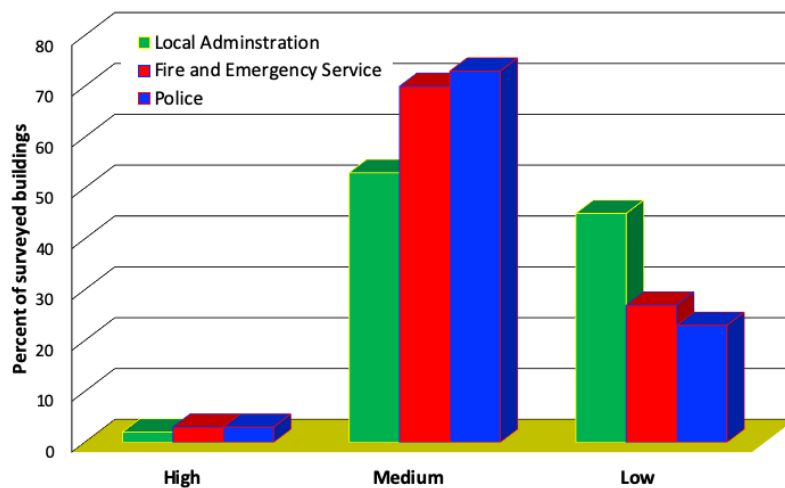
construction. Large proportion of the buildings of all the three departments depicted medium quality of construction. Only 2.08%, 3.33%, and 3.35% of the local administration, Fire and Emergency Service, and Police exhibited high quality of construction, respectively. While majority of buildings; 53.16%, 70.00%, and 73.22% of these buildings, respectively, depicted medium quality of construction (Fig. 10).

Figure 10. Construction quality of the surveyed buildings

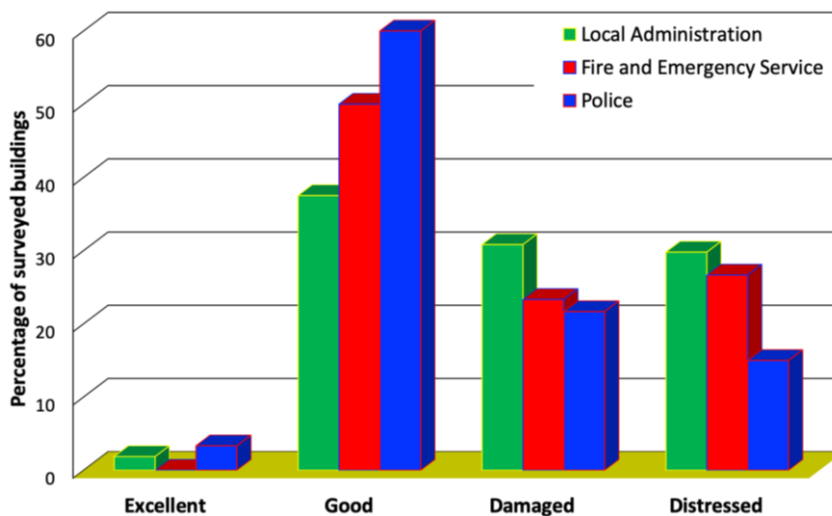
Of the surveyed buildings only 1.87% and 3.33% of local administration and Police buildings were in excellent condition, respectively; while 37.52%, 50.00%, and 60.00% of local administration, Fire and Emergency Service and Police were in good condition, respectively and 30.82%, 23.33%, and 21.67% of these departments were in damaged condition, respectively (Fig. 11).

Figure 11. Building condition of the surveyed buildings

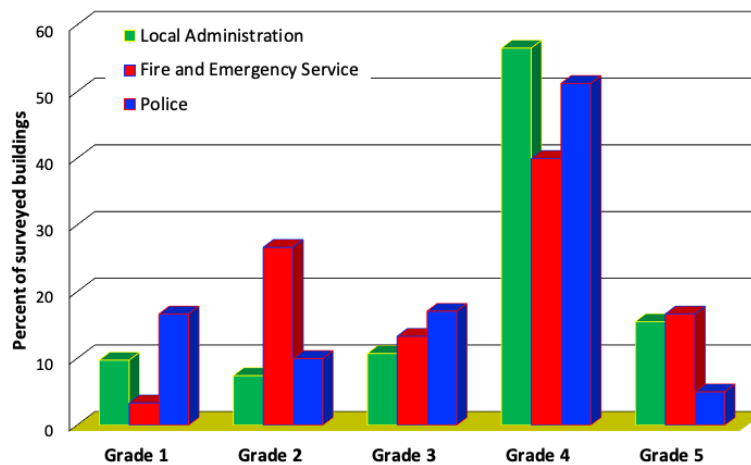
For assessing vulnerability of the surveyed buildings, scores assigned to various surveyed constituents (BSH and PMF) were integrated, and the buildings were classified into five damageability grades based on the final structural score (S); ≤ 0.80 = Grade 5, 0.81-1.60 = Grade 4, 1.61-1.80 = Grade 3, 1.81-2.00 = Grade 2 and > 2.00 = Grade 1 (Fig. 12).

Figure 12. Damageability of the surveyed buildings

The cost of improving seismic performance of buildings in Grade 5 was high; therefore, it is recommended to demolish and reconstruct them. Retrofitting of the buildings in Grade 4 and Grade 3 is recommended as this can be done with an average investment of around 20% of their replacement value (10).

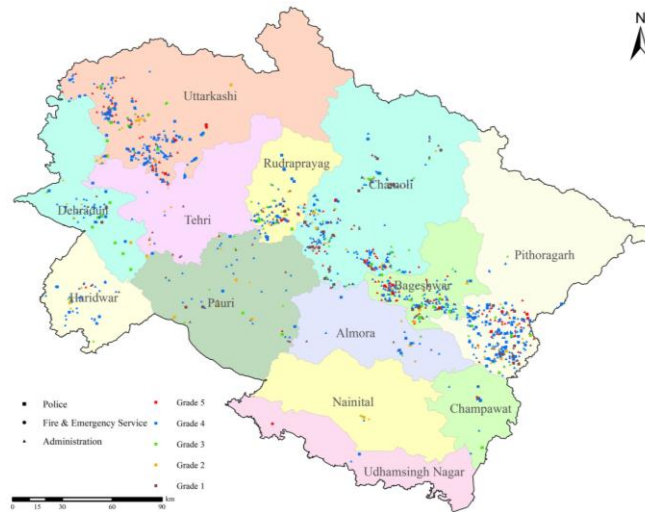
Table 5 reveals that 9.59%, 60.57%, and 17.22% of the masonry buildings, respectively, fall in Grade 3, Grade 4, and Grade 5 and were likely to be damaged during the seismic event. The vulnerability of the masonry buildings was particularly high in Uttarkashi district where 32.38% fall in Grade 5 while 63.52% fall in Grade 4 (Fig. 13).

Figure 13. Spatial distribution of surveyed buildings with different damageability grade

In view of the escalated hardships and misery of the affected population, it is recommended that the buildings in Grade 5 be demolished, and reconstructed. In view of particularly high vulnerability of masonry buildings in Uttarkashi district, and RCC buildings in Bageshwar, Haridwar, Almora, and Rudraprayag districts, it is recommended that these districts be accorded high priority while implementing corrective measures.
