# An Overview of Disaster Management during the April 25, 2015, $M_w$ 7.8 Nepal Earthquake

Mehdi Zare<sup>1\*</sup>

This study reports observations from the disaster management efforts and responses to April 25, 2015, Gorkha earthquake based on a visit epicentral region in Gorkha district and the affected cities performed by the first two authors during 6-11 May 2015 (**Figure 1**). Based on the

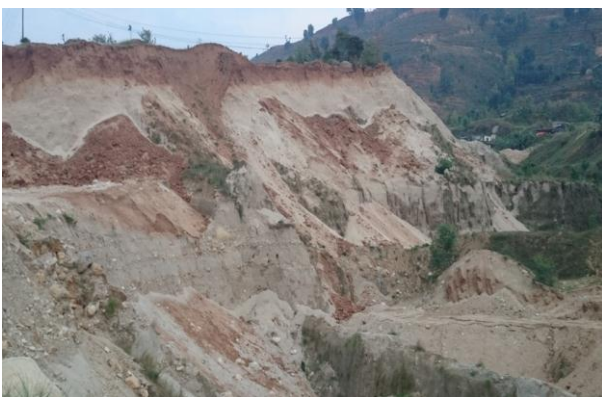
Following the 2015 earthquake, several earthquake-induced landslides, avalanches, ground fissures, and fault ruptures. Based on the observations, the earthquake triggered some new landslides along the intercity road from Kathmandu westward to Gorkha and Pokhara. At about 62 km west of Kathmandu, a relatively large landslide could be observed with an approximate size of 100m width \* 50m length (Figure 2).

**Figure 2.** An observed landslide with about 100m width and 50m length, 62 km west of Kathmandu.

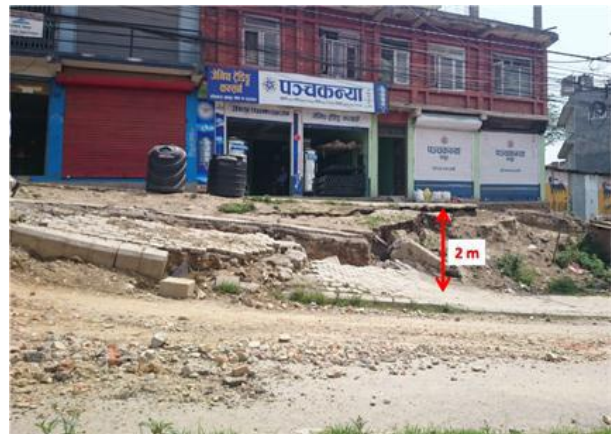
Because of the continued aftershocks occurred throughout Nepal in the first weeks, the country also had a continued risk of landslides. Moreover, the earthquake sparked an avalanche on Mount Everest and a huge avalanche in the Langtang valley, blocking mountain routes, killing several individuals and missing hundreds. Furthermore, a typical ground fissure was observed at a distance of about 9 km southeast of Kathmandu toward Bhaktapur with a NE-SW direction and 2-meter vertical displacements (Figure 3).

**Figure 3.** A typically observed ground surface fissure with NE-SW direction between Bhaktapur and Kathmandu.

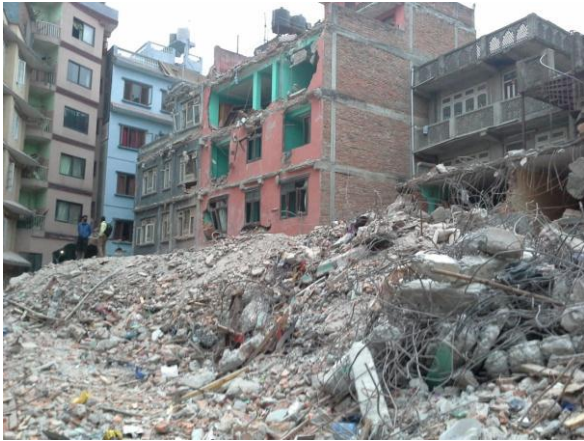
In all the visited areas, there were many low-resilient buildings that were fully collapsed, tilted or severely damaged. The fourteenth day after the earthquake, large amounts of debris from destroyed buildings were not cleaned, making the affected areas to be so unsightly and polluted. The destructions in Gorkha District as well as Langtang village in a 60-kilometer distance northeast of Kathmandu. In Kathmandu, Unfortunately, disorganization and confusion in some developed regions were more evident than other less developed regions. For instance business and shopping centers and residential complexes sustained major damages (Figure 4).

**Figure 4.** Severe damages to the building in Kathmandu.

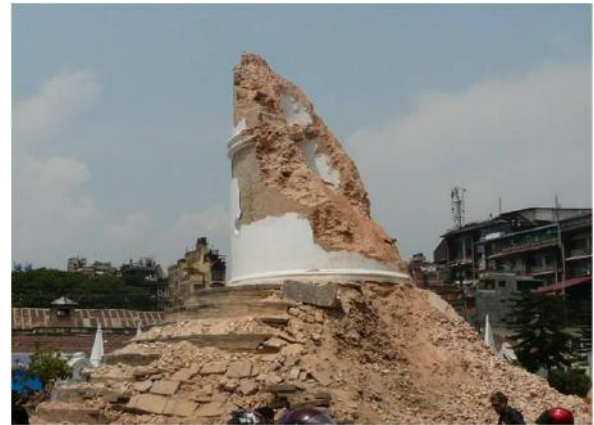
**Figure 5.** Destroyed historic/cultural world heritage Durbar Square of Kathmandu

The 2015 Gorkha earthquake almost destroyed all the world heritages in the Durbar square of Kathmandu, as well as the 183-year-old nine-storey Dharahara tower at the center of Sundhara (**Figure 5**). A similar situation was observed in the Bhaktapur Durbar Square situated about 12 km southeast of Kathmandu (**Figure 6**). Visiting the Swayambhunath Buddhist temple (also known as the Monkey Temple) (**Figure 7**), some important parts of the temple and one of its adjacent towers were found to be destroyed.

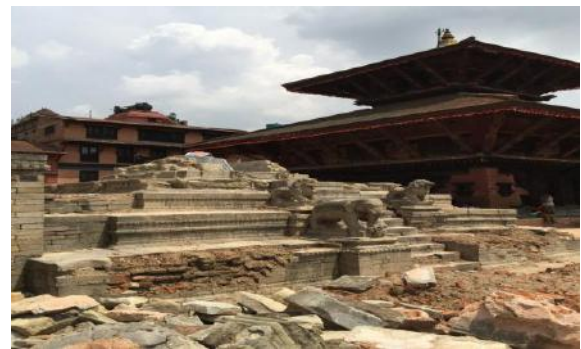
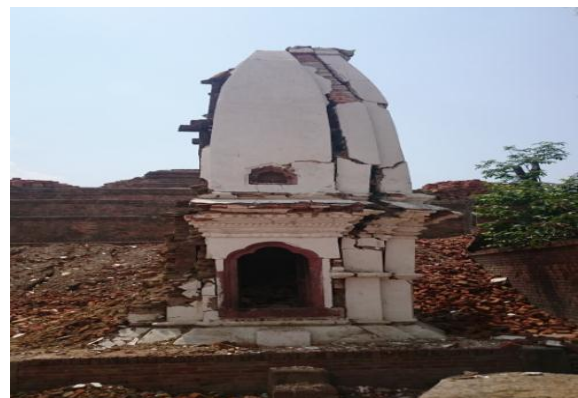
**Figure 6.** Destroyed historic monuments at Durbar Square of Bhaktapur.

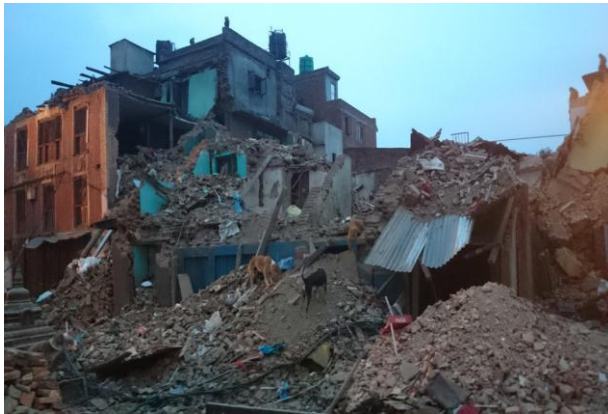
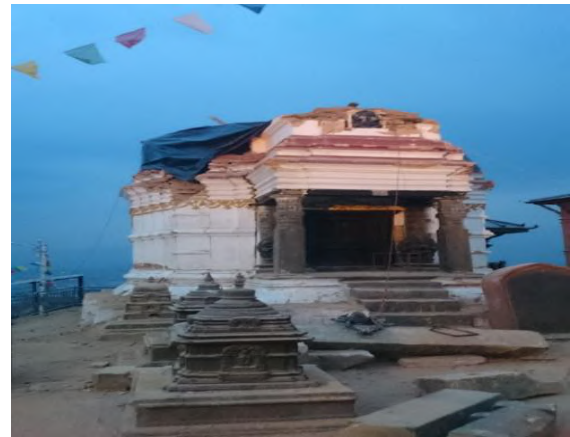
**Figure 7.** Damaged Swayambhunath Buddhist temple west of Kathmandu.

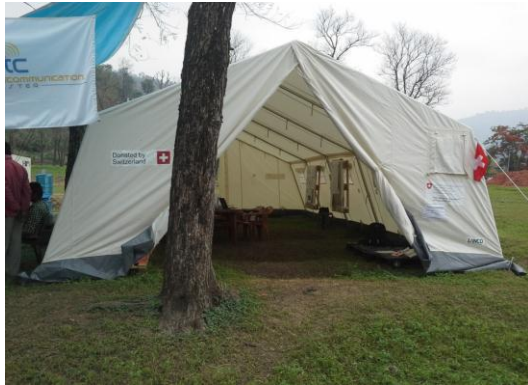
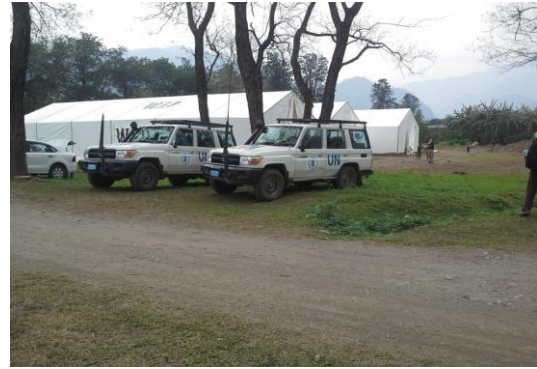
**Figure 8.** The UN logistic camp at Abu Khaireni village in Gorkha district.

At Abu Khaireni, south of Gorkha district, the United Nations World Food Program (WFP) had established a logistic camp to control and distribute donations such as food, health packages and emergency shelters to the earthquake-stricken area (**Figure 8**). This logistic camp was also responsible to coordinate the headquarters of the national and international agencies and NGOs by holding a meeting between relief teams and response clusters at 8 o'clock each morning. Despite the good discipline among the working groups, there was a shortage of vehicles to transport the donated facilities. Only one helicopter and 20 to 25 trucks were employed per day to transfer relief packages to the epicentral area, meanwhile, the trucks were not always available regularly. According to the head of the camp, during the first 72 hours of the emergency period, one helicopter and 40-50 trucks were needed per hour, while after passing the period, it was estimated that more than seven times of this amount of equipment were needed in order to deliver the aid to begin reconstruction and rehabilitation in the affected areas. Meanwhile, the Nepalese government's facilities in this context are limited and it is not possible to increase the capacity and supportive equipment.

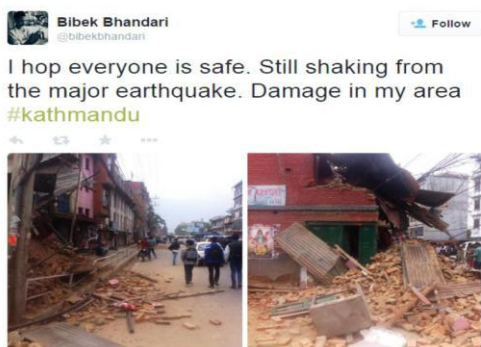
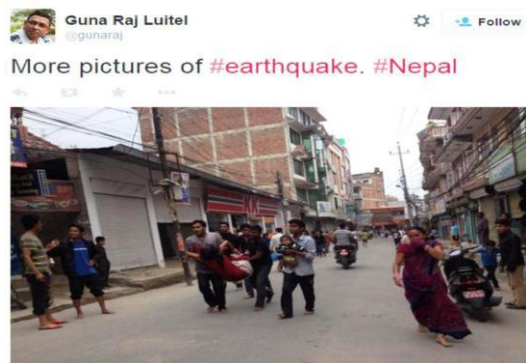
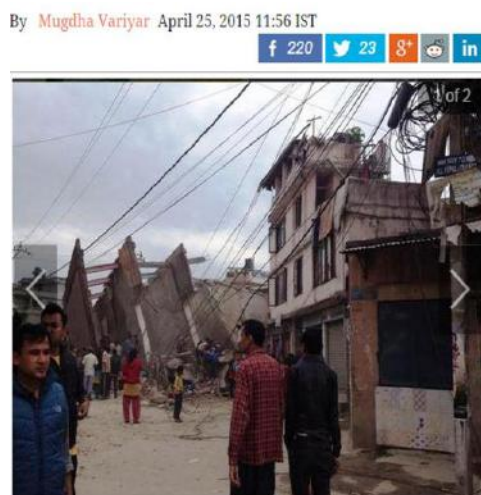
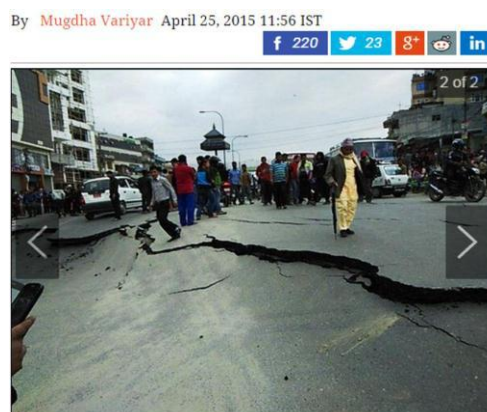
**Figure 9.** The first news of the 25 April 2015 earthquake released worldwide by Nepalese social network users at the moment and early minutes of the event.

The first news about the earthquake occurrence and its damages were released around the world using the internet through photos and text messages published by the Nepalese social network users at the moment and early minutes of the tremor (**Figure 9**).

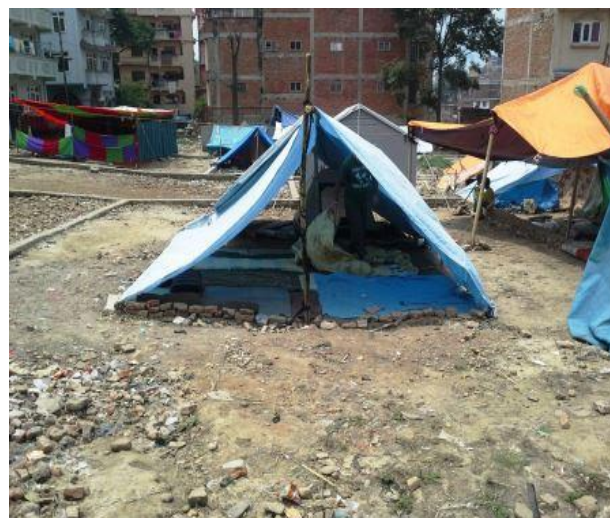
**a):** If the private damaged houses did not collapse fully and it was possible to bring the essential appliances outside, the owners tend to stay beside their houses; so they set up their temporary shelters next to their houses. Most of these emergency temporary shelters were only plastic sheets that were distributed throughout the cities and people themselves had set them up as tents without side walls using remained bamboo reeds and wooden beams of their houses (**Figure 10**). A large number of these kinds of emergency shelters were observed in which there were no basic hygiene amenities such as toilets and bathrooms. The residents refuged to these tents only at night or during rain. The Food and clean drinking water were provided by the affected people themselves in an extremely difficult way and there was no humanitarian assistance in these shelters.

**Figure 10.** Handmade temporary tents that owners had made using plastic sheets, bamboo reeds and wooden beams beside their houses in urban areas.

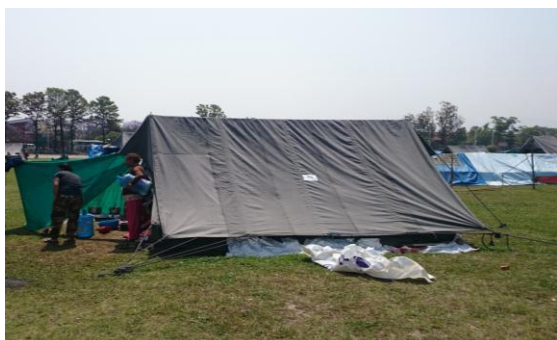
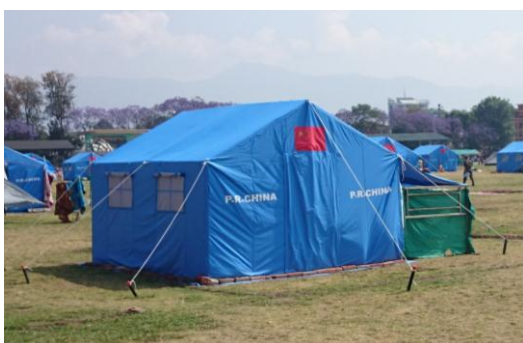
Kathmandu and Bhaktapur, two types of tents donated by China and India were used. It was observed that the Chinese tents had better quality and design than the Indian ones. All the Chinese tents were made of resistant steel frames with a two-layer cover, a surface waterproofing cover and an internal thermal insulation cover, while the Indian tents were made of a single layer canvas cover. With regard to the weather conditions in Nepal such as cold winter and heavy rainfall, the quality of the used tents is very important for the residents of the camps. Although the Chinese tents had a very good quality, unfortunately they were not set up correctly in Kathmandu so the rainwater had penetrated into the tents and all parts of the the tents and also the clothes got wet (Figure 11).

**Figure 11.** Emergency tents in public camps of Kathmandu and Bhaktapur donated by China (Right) and India (left)

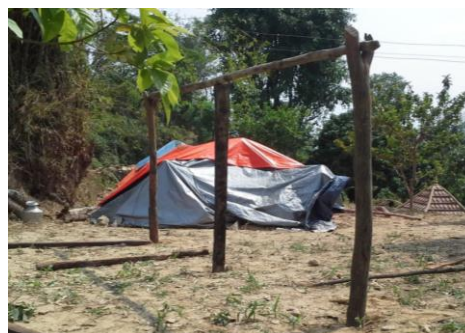
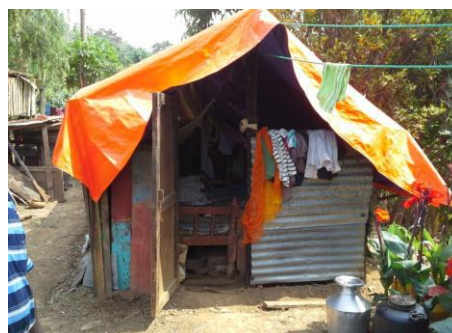
plastic covers were distributed instead of tents. In order to set up temporary shelters in these villages, some people had made frameworks using bamboo trunk which were covered by plastic sheets. Most of these shelters lacked side walls and would simply be blown away by the first gust of wind. Some of the villagers skilled in carpentry and masonry often tried to build very basic cottages using the remaining materials of their building debris. Most of these houses had a wooden skeleton with bamboo straw sidewalls. Doors and windows of the destructed houses were also used as the doors and windows of the new houses and metal corrugated sheets or plastic coating were used to cover the ceiling (Figure 12). In none of these villages, there were no appropriate tents such as tents which were installed in the cities of Kathmandu and Bhaktapur.

**Figure 12.** Handmade temporary tents that owners had made using remained parts of their houses in rural areas.

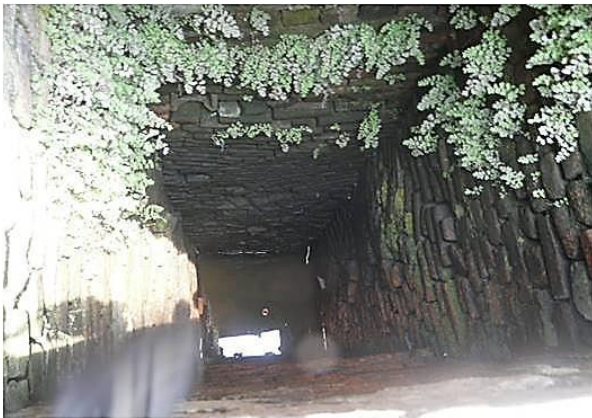
problems in Nepal. About 50% and less than 30% of the population has good access to treated water during rainy and dry seasons, respectively. After the earthquake, treated water was distributed daily by local and international NGOs among the affected people of Kathmandu. According to a senior official of the water organization in Kathmandu, the country is only able to provide one-third of the needed treated water during the annual rainfall and only a quarter of the treated water in dry seasons for the population. Although, the depth of the groundwater level in some parts of Kathmandu was measured to be about 3-6 meters (**Figure 13**), it is not useable due to the water pollution especially the existence of heavy metals. Thus, treated water is distributed throughout the city using tankers.

**Figure 13.** Groundwater level mostly in western parts of Kathmandu with about 3-6 meter depth.

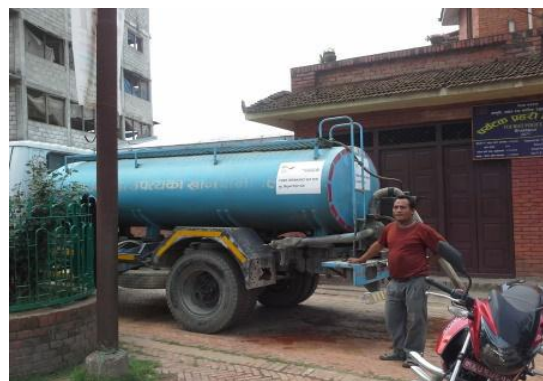
of their water filtration system into 120,000 Lit/day but there were not enough facilities to distribute even that 10,000 Lit/Hour of clean water. Kathmandu's Water Organization had promised the German team to have 5 trucks to distribute clean water daily, but actually, less than 5 trucks were available. Without the occurrence of an earthquake, Kathmandu is a city where there are so polluted water supplies extracted from wells. Moreover, about 360 million liters of clean water are needed per day; while only 130 and 90 million liters of clean water are daily available in rainy and dry seasons respectively. In Bhaktapur, water was extracted from in-situ wells (**Figure 15**) and was refined and distributed by the German team.

**Figure 14.** Providing treated water in the Water Organization of Kathmandu by a German specialist team and distribution of it throughout the city by trucks.

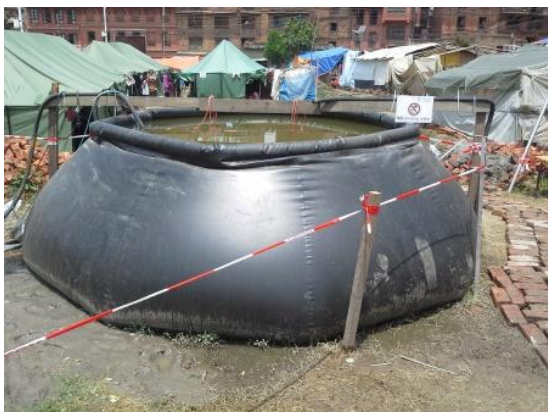
**Figure 15.** Providing treated water in Bhaktapur from extracted water of in-situ wells by a German team.

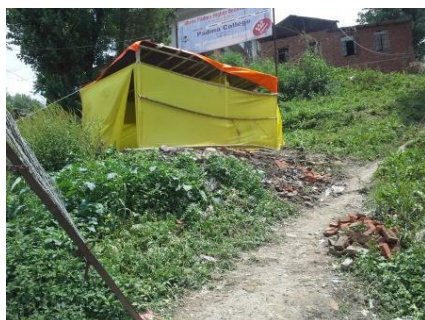
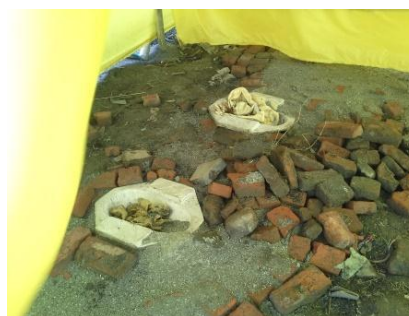
In the camp of Kathmandu, residents had to use the public restrooms of Tundikhel Parade, while these services lacked appropriate quality and standards. In the camp of Bhaktapur, two emergency health services were initially set up which were closed during the first week of use, due to the wrong location of these two services (up of the slope toward the camp), and the wastewater penetrated into the camp. After a while, the health services installed for tourists were used instead (**Figure 16**).

**Figure 16.** Prepared health services in the public camp of Kathmandu.

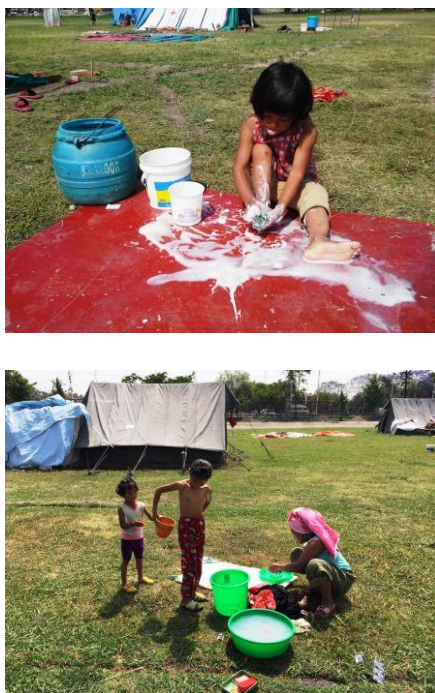
After the earthquake, one of the basic needs of the contact groups is to use proper facilities for washing and bathing. Lack of attention to these basic needs may not have tangible feedback during the first two weeks, but over time, due to the incidence of skin diseases, especially infectious diseases like fungal, it poses serious problems to crisis managers which will be very costly and time-consuming. Unfortunately, there were no bathrooms in both camps of Kathmandu and Bhaktapur and families act to wash their children in the outdoor area (**Figure 17**). In addition, no toilets or bathrooms were set up in the visited villages, and most villagers had to use the rural health services commonly which were remained intact after the earthquake.

**Figure 17.** Washing and bathing outside the public camps in Kathmandu and Bhaktapur.

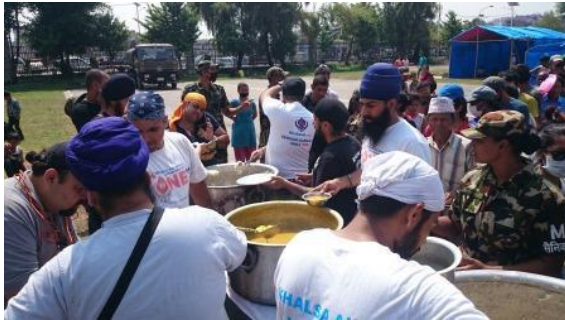
In both camps of Kathmandu and Bhaktapur, the production and distribution of hot food were performed by local and international NGOs (**Figure 18**). Although the food was distributed in the camps freely, families often were reluctant to receive these foods and they tend to cook in their tents. Therefore, managers of the camp had started to distribute raw materials for cooking by families.

**Figure 18.** Preparing hot food by international NGOs in public camps.

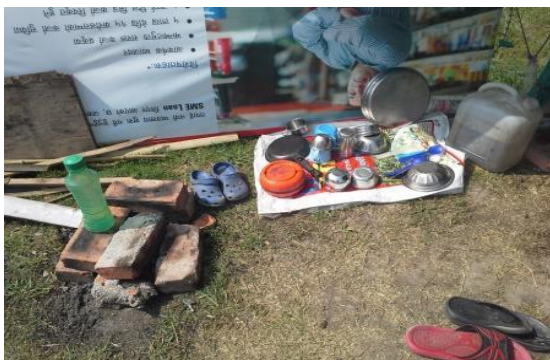
Given that all camp residents in the city of Kathmandu and Bhaktapur were families whose houses were completely destroyed, providing basic amenities of life for them might be certainly a priority for crisis managers while this could not be seen in the first 12 days after the earthquake. Supplying waterproof mats, blankets, warm clothes, underwear for women and children and basic cookware are the main priorities that should be supplied as soon as possible (**Figure 19**).

**Figure 19.** Lack of appropriate basic amenities for life in emergency public camps.

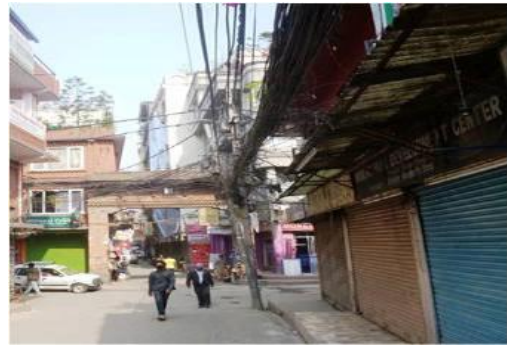
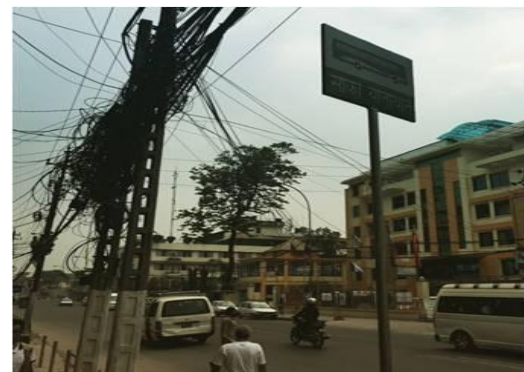
There is a complicated and dangerous wire system transmitting electric power in Kathmandu (**Figure 20**).

**Figure 20.** A dangerous and complicated power wires system in Kathmandu
