# Intra-Pelvic Penetration of Broken Guide Wire during Fixation of Hip Fracture: Presentation of a Case and Review of Literature

**Case Report:** We presented a case of intertrochanteric fracture with breakage of the lag screw guide wire in the acetabulum during fixation with cephalomedullary nail. The broken fragment was located with computed tomography (CT) scan and removed through Stoppa approach.

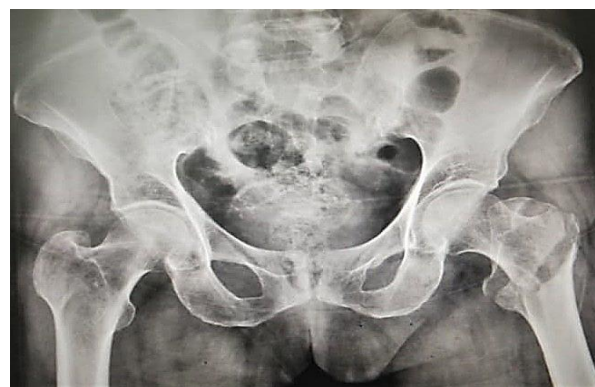
An 83-year-old female was admitted to the orthopedic ward with intertrochanteric fracture caused by falling. The patient's weight and height were 56 kg and 170 cm, respectively [body mass index (BMI): 19.3 kg/m<sup>2</sup>]. Her past medical history was unremarkable except for osteoporosis. On radiographic assessments, the fracture pattern was compatible with type 31-A2 AO Foundation and Orthopedic Trauma Association (AO/OTA) fracture classification (Figure 1).

**Figure 1.** Preoperative radiograph of the left hip with intertrochanteric fracture [AO Foundation and Orthopedic Trauma Association (AO/OTA) type 31-A2]

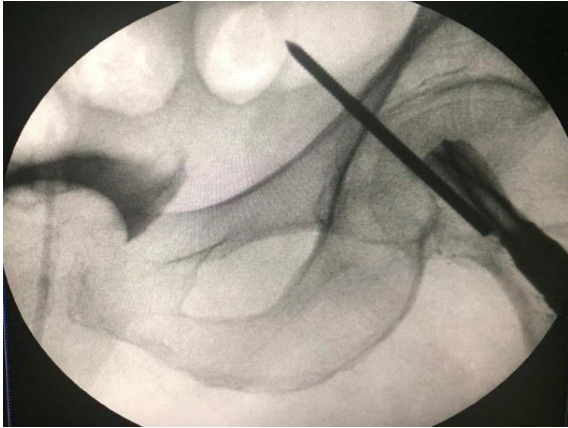
The repeated intraoperative imaging showed that the broken fragment had penetrated the acetabulum (Figure 2). The guide pin was migrated into the acetabulum during forceful reaming and was broken when inserting the lag screw with improper direction, probably due to osteoporosis.

**Figure 2.** Intraoperative imaging of the left hip, revealing intra-pelvic broken guide wire

In our case, the most probable cause of the guide wire breakage was reaming with a divergent angle. Consecutively, it resulted in bending of the wire, stuck of the reamer, forceful reaming, migration of the wire, and the final breakage. Therefore, several intraoperative control imaging during guide wire placing, reaming, and device insertion is recommended to confirm the proper position and direction of all tools. Furthermore, it is recommended to check the wires before application to avoid reuse and ensure the absence of bent or erosion. Cannulated devices should also be inspected for canal blockage. Using a blunt drill bit or reamer may result in a forceful reaming and should be avoided.

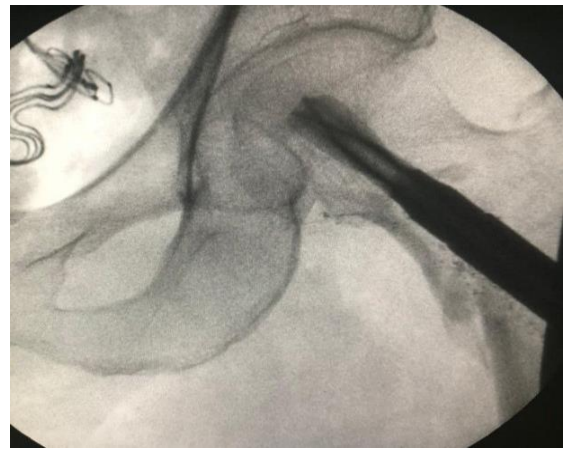
**Figure 4.** Intraoperative imaging of the left hip after removing the broken guide wire

The exact location of the broken guide pin was assessed with postoperative computed tomography (CT) scan. After consultation with a vascular surgeon, a CT angiography was performed, which showed no sign of vascular injuries. However, due to the high risk of pin moving and the possibility of neurovascular or urological injuries, the patient was transferred to the operating room the next day for removing the broken pin. The surgery team included an orthopedic surgeon, an urologist, and a vascular surgeon. The suprapubic region was opened with the modified Stoppa approach. Exploration of obturator neurovascular structures and corona mortis revealed no injury. Then, the broken pin was extracted from the inner table of the pelvis and the extraction was confirmed with intraoperative imaging (Figures 3 and 4).
