## Management of Separated Instruments Using Ultrasonic Technique and a Novel Loop Device (Kamand): A Case Report

#### Article Type: Case Report

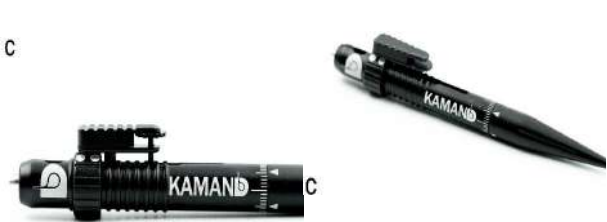
Figure 2. A) Modified Gates Glidden bur utilized for creating a staging platform coronal to the separated instrument. This preparation provides direct visualization and straight-line access to the fragment. & B) ED87 ultrasonic tip (Woodpecker) employed.

Dental (ZT Dental, Tangshan Hengxin Medical Supply Co, China) Teflon tape to maintain a clean operating field. Under magnification with a Zumax dental operating microscope (Zumax Medical Co., China), specifically the Zumax model 2380, a modified Gates Glidden #2 bur (Mani Inc., Japan) was used to create a staging platform coronal to the separated fragment. An ED87 ultrasonic tip (Woodpecker, Guilin Woodpecker Medical Instrument Co., China) was then carefully used to create a 1mm space around the coronal aspect of the broken instrument. After conservative dentin removal from the inner wall of the canal curvature (adjacent to the danger zone), the space for needle penetration was examined. The tip of the 27-gauge needle was placed in the created space beside the fragment, 1 mm below the fragment's surface. The loop formed in the wire was then approximately sized to match the cross-sectional area of the fractured piece using a NiTi spreader. After the needle and wire were properly positioned, the main screw of the Zumax Kamand was slowly turned counterclockwise to securely grasp the fragment with the wire. Then, gentle lateral movements were applied to the fragment, and the fragment was subsequently removed.

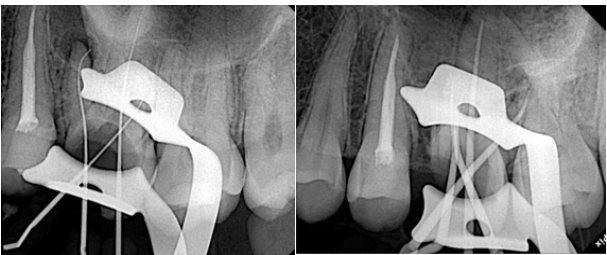
Figure 3. Working length determination (A), Radiographic confirmation of master Apical cone (B).

Following instrument retrieval, all canals were negotiated with a #15 K-file (Mani Inc., Japan). Working lengths were determined using an electronic apex locator (Propex IQ, Dentsply Sirona, USA). All canals were instrumented to size 25/.04 using M3 rotary files (UDG, Changzhou, China) and irrigated with 2.5% sodium hypochlorite solution (Kobalt, Tehran, Iran). Patency was maintained throughout the procedure using a #10 file. Final irrigation was performed with normal saline for 2 minutes using a 30-gauge side-vented needle (UDG, Changzhou, China). Root canal obturation was completed using the warm vertical condensation technique with Meta gutta-percha points (Meta Biomed, South Korea) of size 25/.04 taper and AH Plus sealer (Dentsply Sirona, North Carolina, United States). The Fast Fill and Fast Pack system (Eighteenth Medical, Changzhou, China) was used for obturation. The tooth was temporarily restored with Coltosol (Coltene, Switzerland) and the patient was referred to the restorative department for definitive restoration.

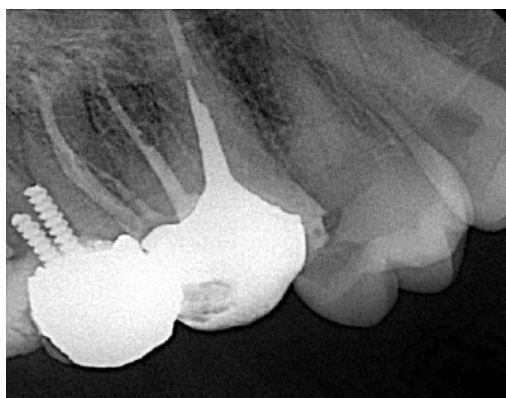
**Figure 9.** Follow-up session showing Final indirect restoration.

At the one-year recall, the patient was asymptomatic. Clinical examination revealed no signs of tenderness to percussion or palpation, and periodontal probing depths were within normal limits. A follow-up radiograph confirmed the placement of a definitive restoration. Although the radiographic angle did not permit a complete view of the periapical tissues, the absence of clinical signs and symptoms was indicative of a successful treatment outcome. (Figure 9).

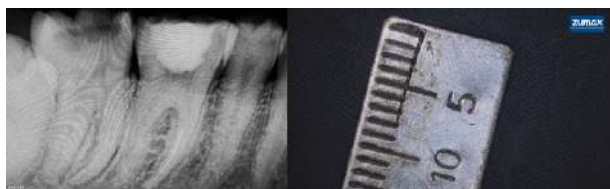
**Figure 10.** Radiograph view showing the separated instrument (A), Retrieved fragment measured approximately 8mm in length following removal (B).

A 33-year-old female patient with a non-contributory medical history was referred to the specialized endodontic department for management of a separated instrument in the mandibular right first molar during RCT. An instrument had fractured during the shaping of the mesiolingual canal. Clinical examination revealed that the tooth was sensitive to both percussion and palpation. Parallel periapical Radiographic examination, utilizing a CMOS sensor (Eighteenth Medical, Changzhou, China), confirmed a fragment approximately 6 mm in length, extending from the mid-canal to the apex, located in the mesiolingual canal (Figure 10). The estimated length of the fragment was 6 mm, and it extended approximately from the middle of the canal to the apex. Given the long length of the fragment, dentin removal up to half the length of the broken fragment would result in significant loss of dentin in the inner wall. Therefore, the retrieval treatment plan was based on the loop technique from the outset. Based on the clinical and radiographic findings, a diagnosis of Previously Initiated Therapy with Symptomatic Apical Periodontitis was made. Given the significant length of the fragment, extensive dentin removal from the inner wall to half its length, as per traditional troughing techniques, would have led to substantial

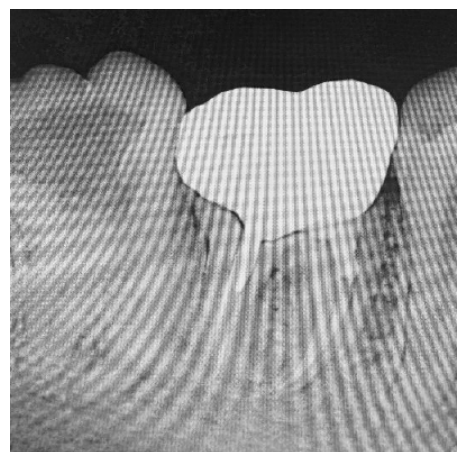
**Figure 12.** 6 month follow-up.

At a six-month and one-year follow-up, the patient remained completely asymptomatic. Clinical and radiographic examinations showed no adverse signs and were consistent with a favorable healing response (Figure 12). The patient was referred for a definitive cuspal coverage restoration.
